UNDERWATER BRIDGE INSPECTION REPORT

STRUCTURE NO. 07514

BLUE EARTH RIVER

DISTRICT 7 - BLUE EARTH COUNTY

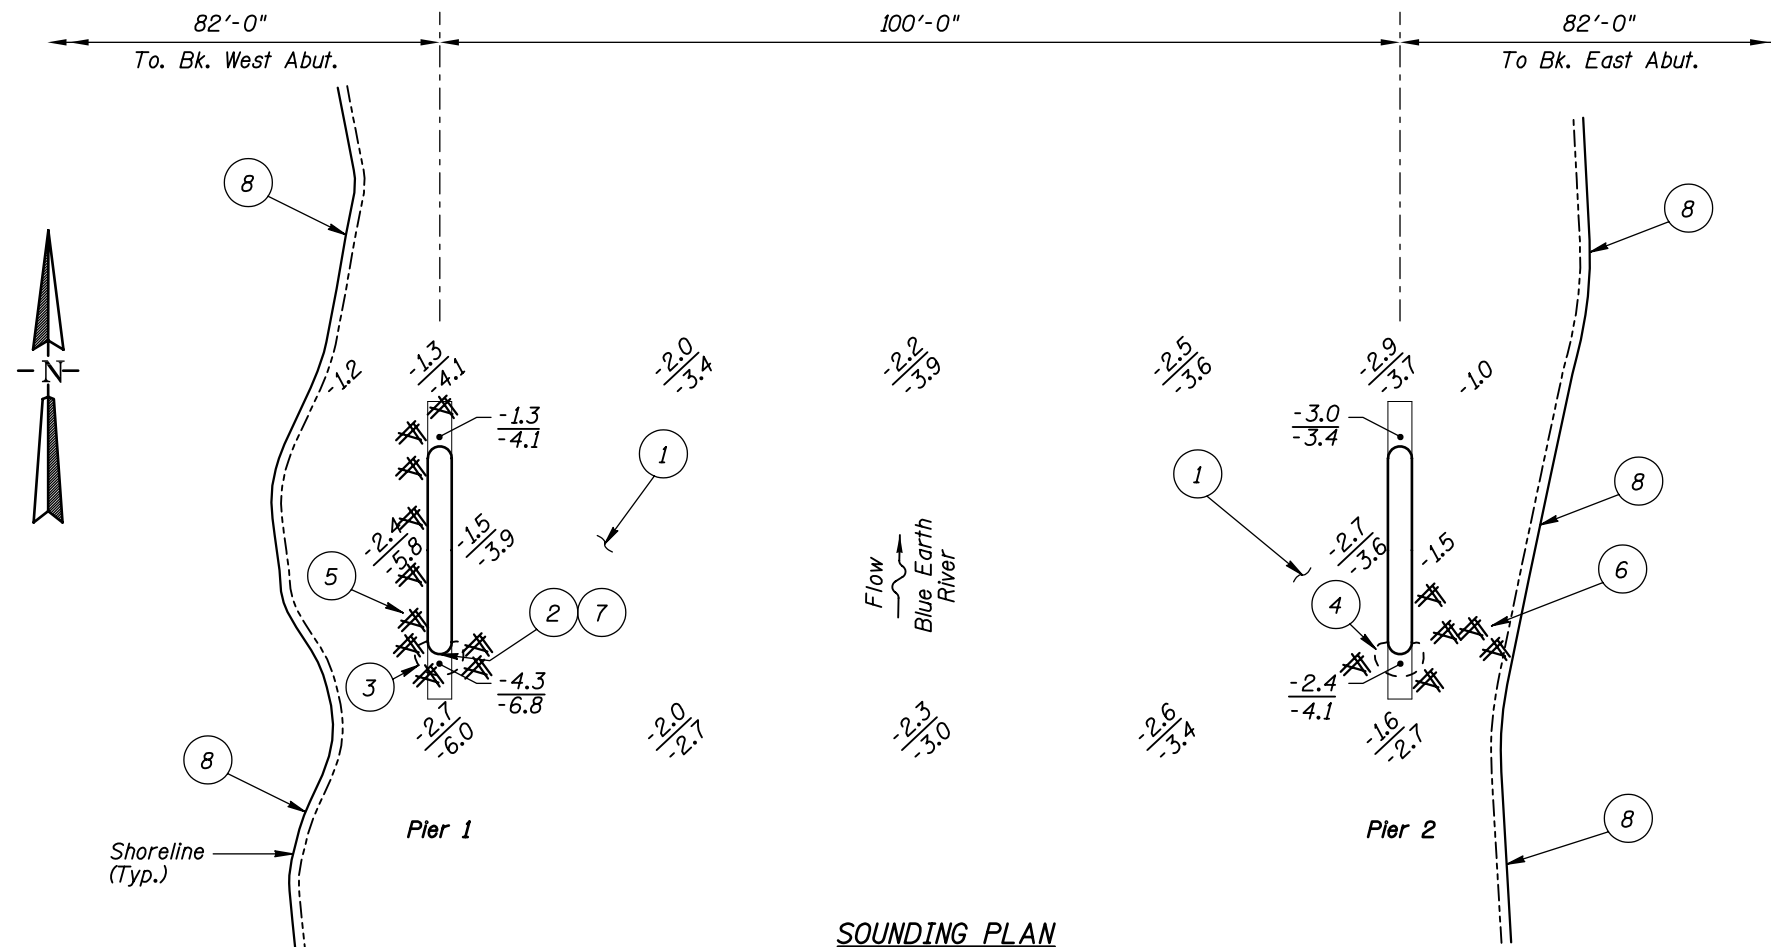
INSPECTION AND SOUNDING PLAN

- 1 The channel bottom consisted of soft silty sand with up to 8 inches of probe rod penetration.
- 2 Minor areas of poor consolidation were observed in the concrete of Pier 1 at the upstream end.

- 3 A scour depression, 2 feet in radius and 1.5 feet deep, was observed at the upstream nose of Pier 1.
- 4 A scour depression, 2.5 feet in radius and 1 foot deep, was observed at the upstream nose of Pier 2.

- 5 A light to moderate accumulation of timber debris, up to 1 foot in diameter, was observed at the upstream nose and along the west face of Pier 1.
- 6 A light to moderate accumulation of timber debris, up to 6 inches in diameter, was observed at the upstream nose of Pier 2 and extended to the east embankment.

- 7 A 1/16-inch-wide vertical crack was observed on the upstream nose of Pier 1 and extended from the waterline to 3 feet above the waterline.
- 8 Minor vertical bank erosion was observed at the east embankment and upstream and downstream of the structure along both shorelines.

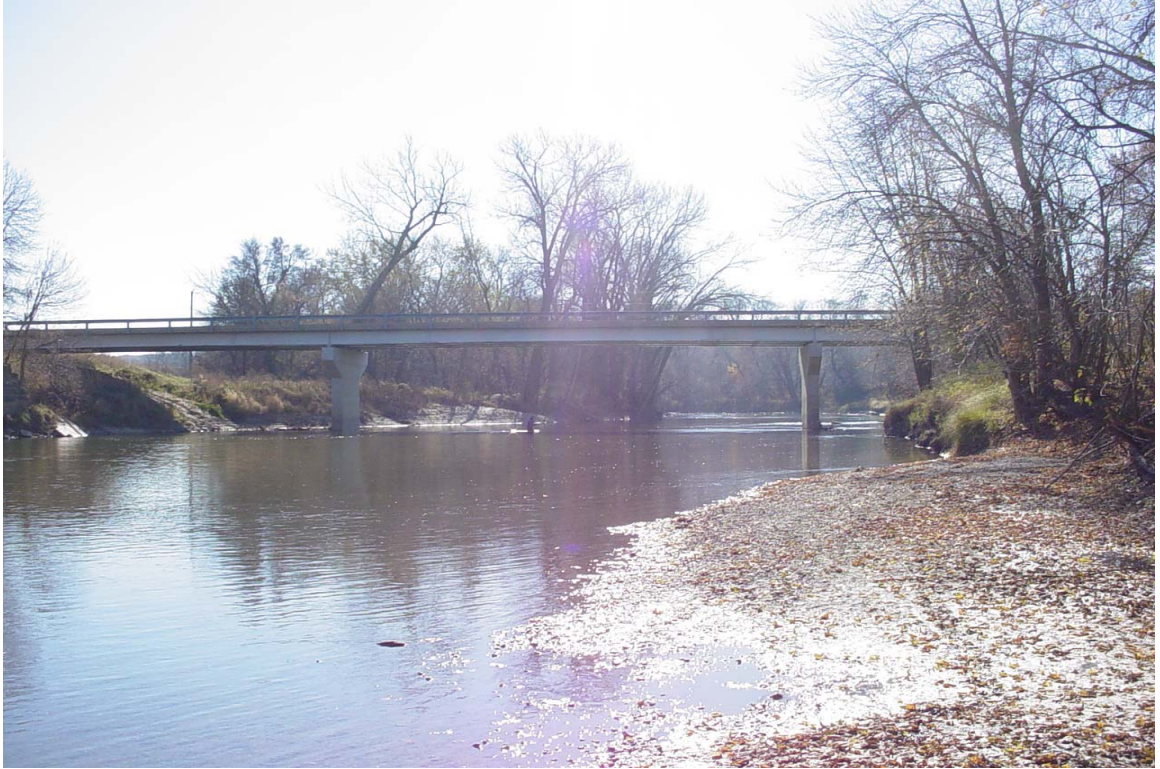
Photograph 1. Overall View of Bridge, Looking South.

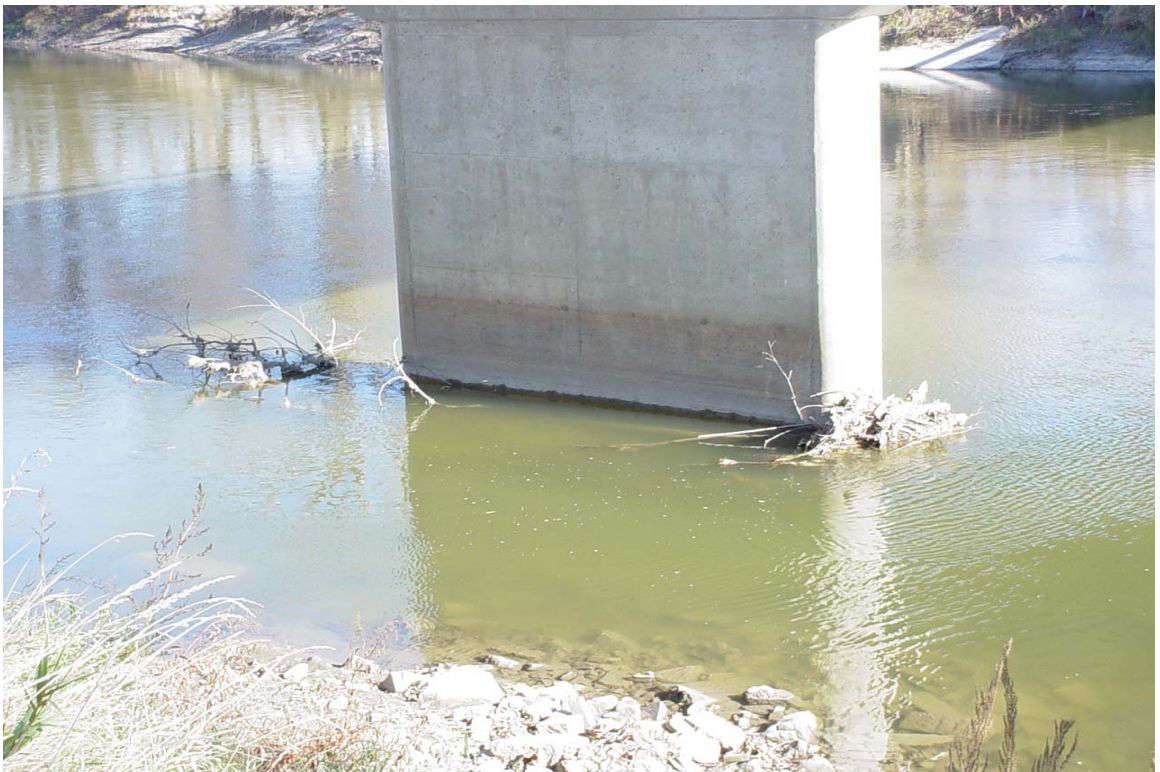
Photograph 2. View of Pier 1, Looking Northeast.

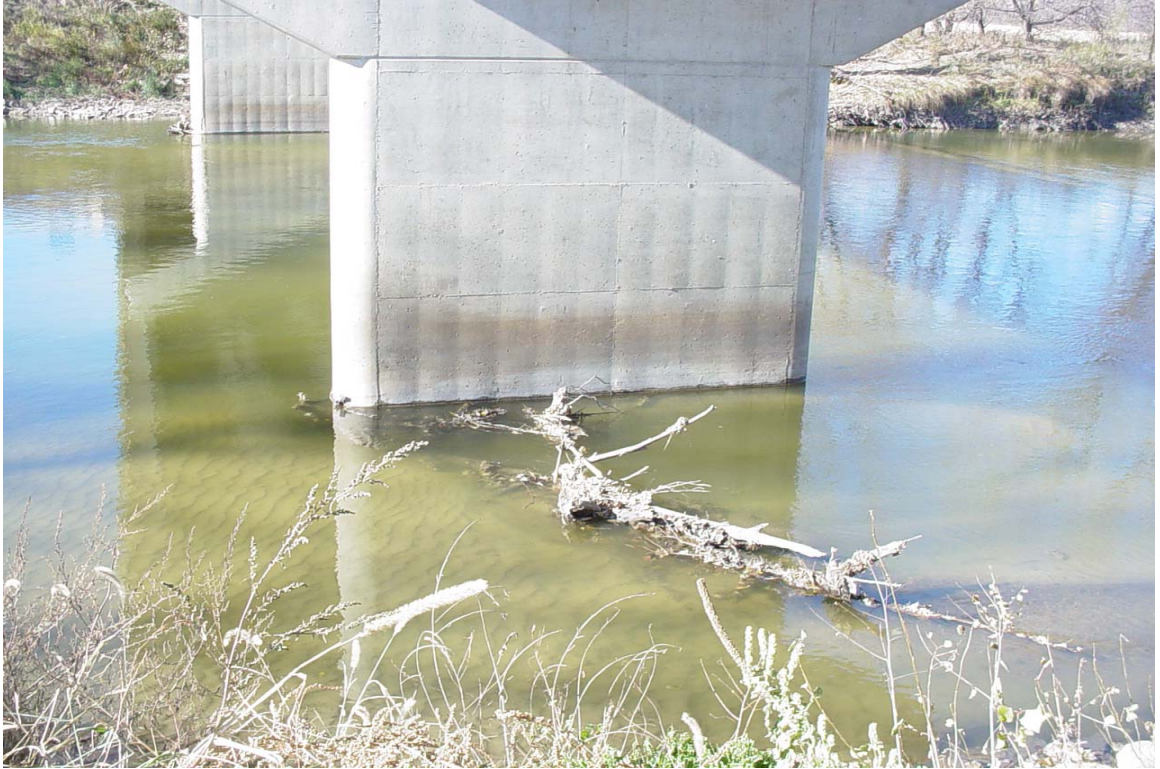
Photograph 3. View of Pier 2, Looking West.

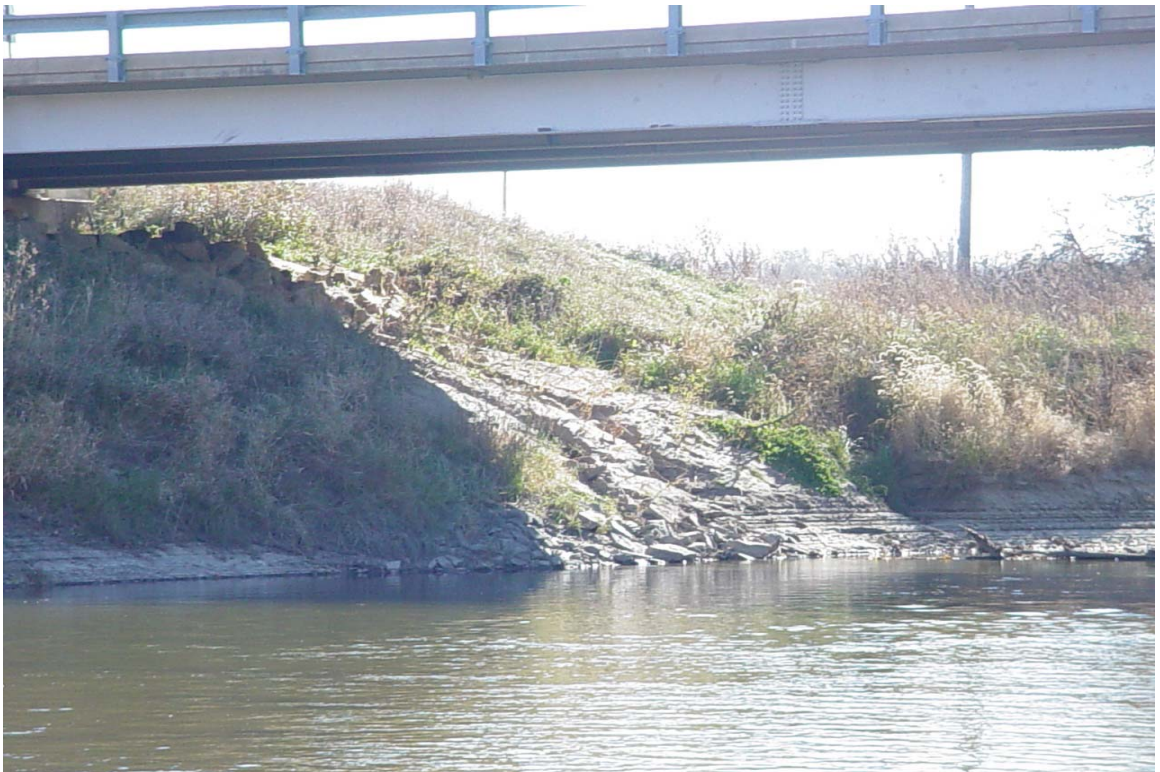
Photograph 4. View of East Embankment, Looking Southeast.
